# SCENARIO OF SEISMIC HAZARD IN ASSAM

## INTRODUCTION:

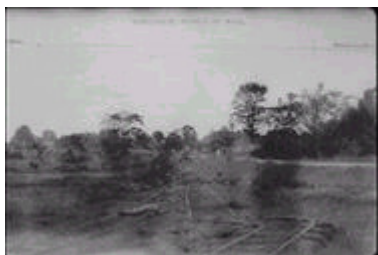
Bent rails at Rangapara,  
Tezpur-Balipara Tramway

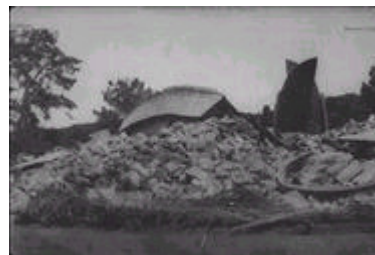
All Saints' Church, Shillong

The earthquake caused great destruction to many towns in Assam and Meghalaya. Most often referred to is Shillong, where most of the structures like the Telegraph House, were demolished. Landslides were reported all across the Garo Hills. The towns of Dhubri, Goalpara, Guwahati and Kuch Bihar in Assam and West Bengal was heavily damaged. Earthquake fountains, some 4 feet high, were reported from Dhubri. The Jolboda and Krishnai bridges were also ruined. At Goalpara, a 10-foot wave from the Bramaputra (possible subsidence), swept into the area, destroying the bazaar and many pukka buildings. Ground waves were reported from Nalbari, where the observer saw rice fields rise and fall as the waves passed under them. At Guwahati, the earth subsided along the Bramaputra and several sand vents were formed. The Bramaputra is also reported to have risen by 7.6 metres and even reversed its flow during the shock. Large scale subsidence was also reported from Muktagacha, Bangladesh. This town was constructed on man-made ground. The earthquake formed frozen earthwaves of "jinamis" in a rice field in lower Assam, where the crest to trough difference was between 2 to 3 metres. Fissures and sand blows occurred over a wide area of Assam, Meghalaya, West Bengal and northern Bangladesh. Fissures and sand blows were also reported from some parts of Bihar.

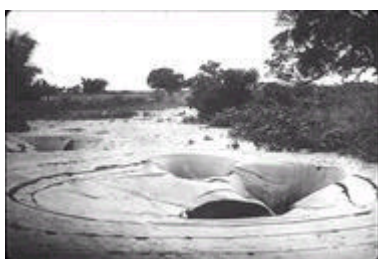
Sand vent at Rowmari

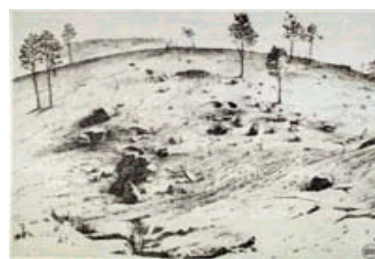
Ground effect in  
Shillong Plateau

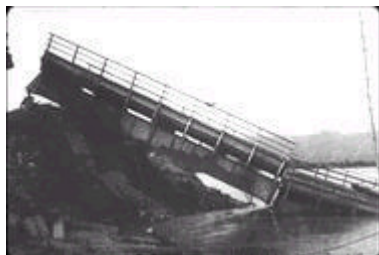
North Lakhimpur, Assam Bridge on Ranganadi Assam.
